# MORSE BOULEVARD LAKE SUMTER SLOPE STABILITY ANALYSIS

## Sumter Landing Community Development District

**Kimley-Horn and Associates, Inc.**

July 2016

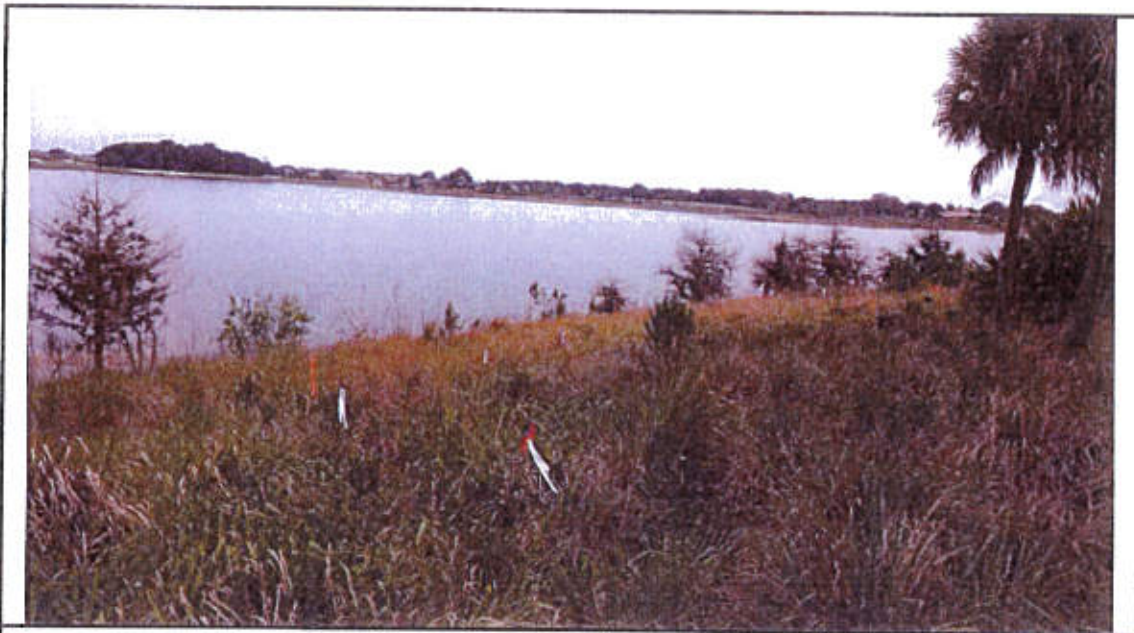
**Photo 1:** Morse Island vegetation cover.

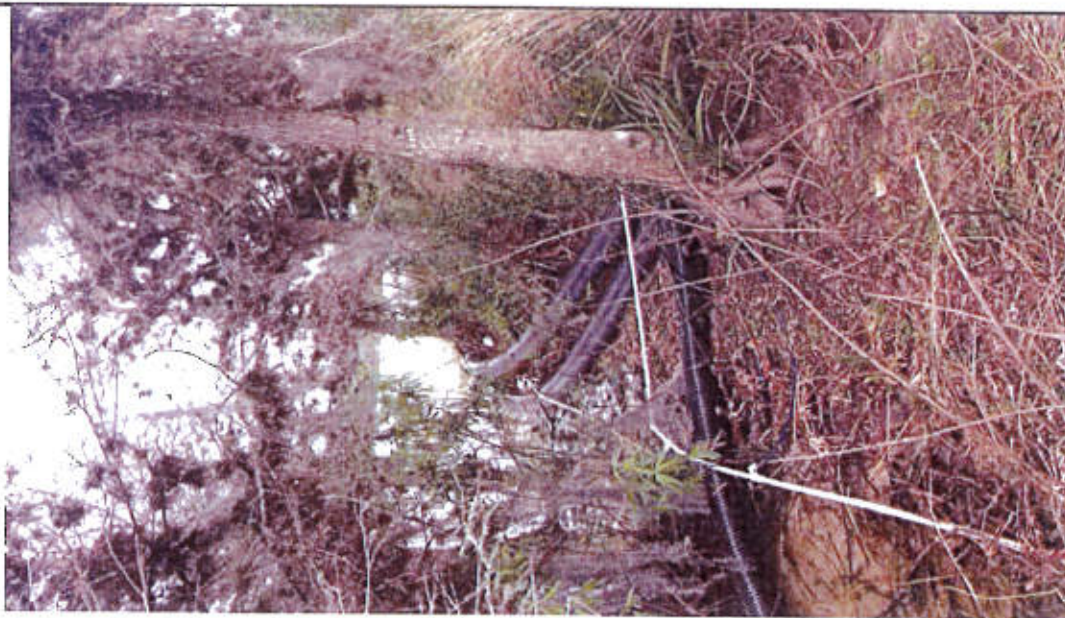
**Photo 2:** Exposed utility and irrigation pipes, northwest corner.

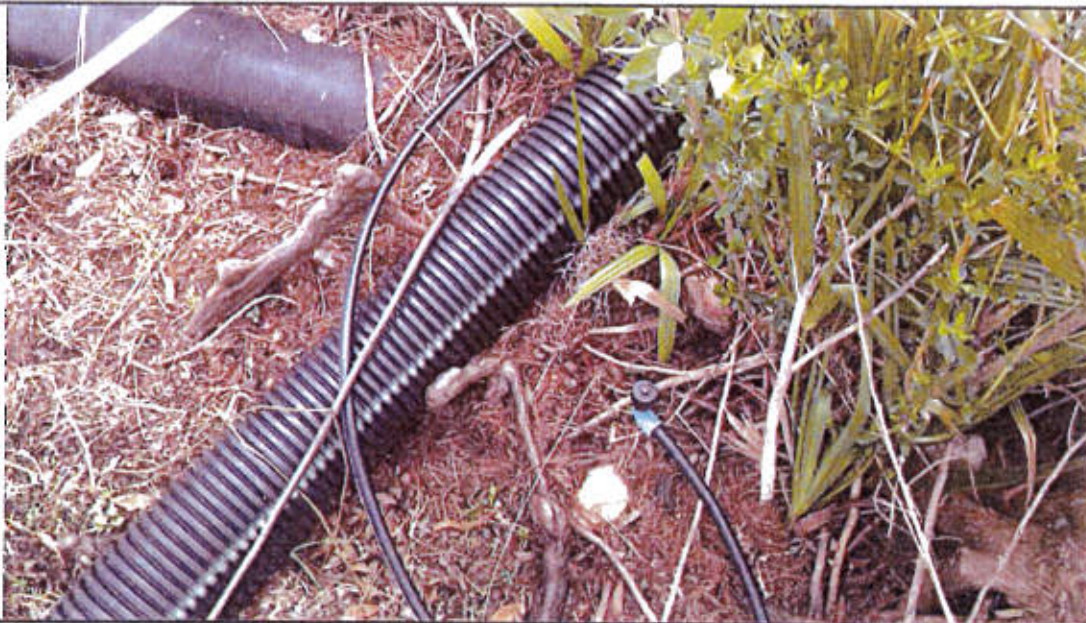
**Photo 3:** Exposed utility and irrigation pipes, northwest corner.

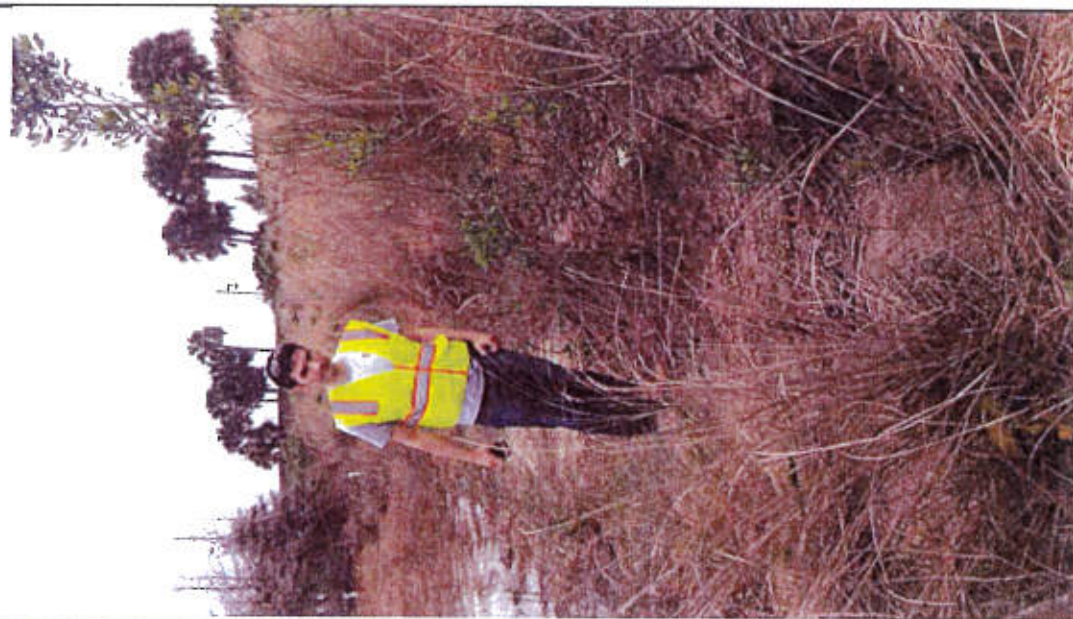
During PSI's site visit, visible erosion of the slope toe at the water's edge was observed. This condition was observed around a majority of the island's perimeter. If gravel or stone rip-rap is used, a filter fabric material should be placed between the existing slope and gravel/stone to prevent soil from migrating into the gravel/stone layer. A woven geotextile fabric meeting the requirements of FDOT is recommended.

**Photo 4:** Slope toe erosion.

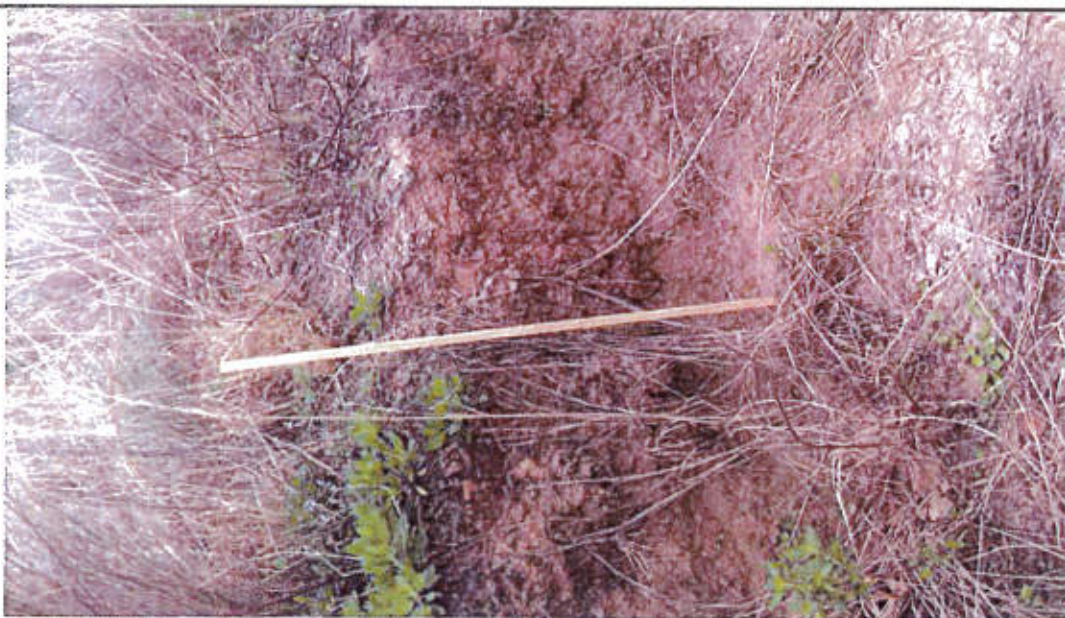
**Photo 5:** Slope toe erosion.

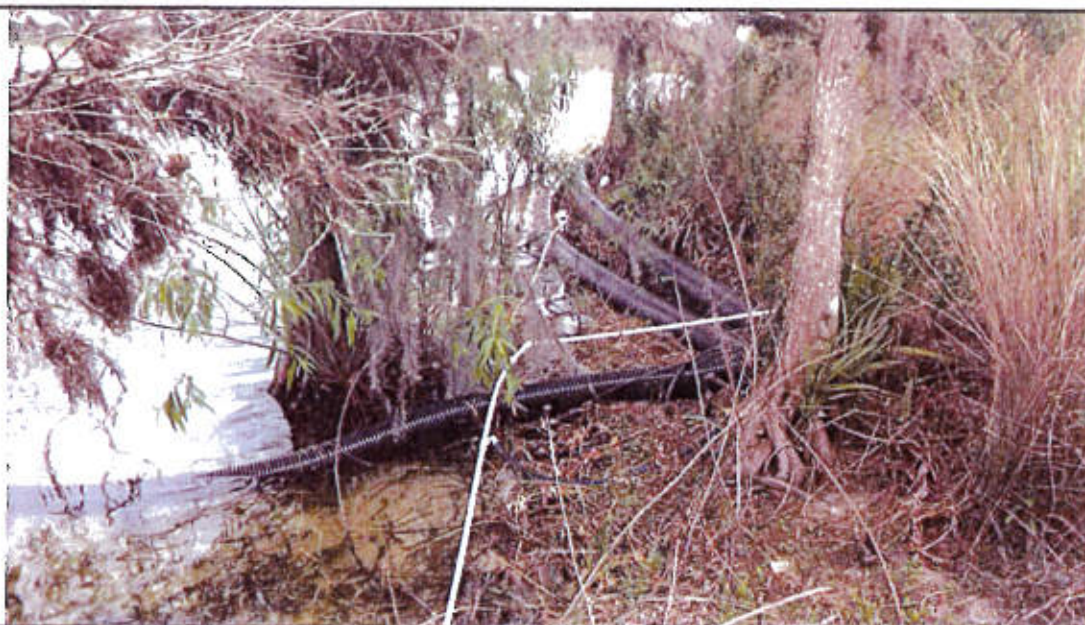
**Photo 6:** Exposed utilities due to slope erosion.

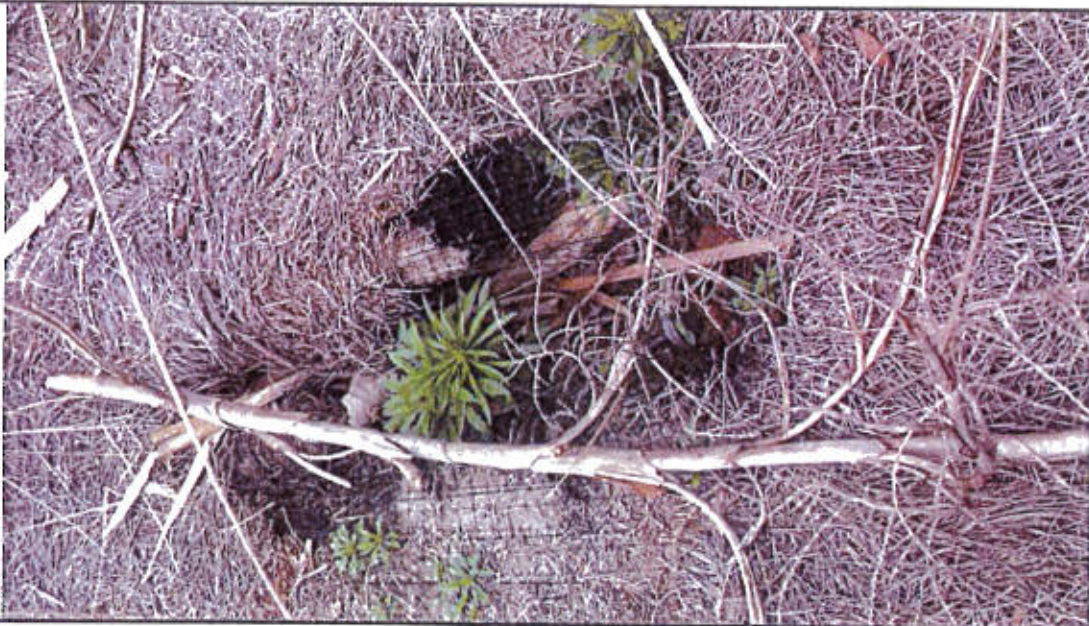
As stated earlier, new signs of surface erosion at the recently reconstructed northeast slope were observed by PSI during our site visit. The erosion appears to be caused by surface water flowing down the slope face, washing the slope soils into Cherry Lake. **Photographs** showing the erosion are included in the **Appendix**. To reduce the surface erosion, maintaining the existing slope by vegetating the slope surface and regular inspection and maintenance should be considered.

**Photo 9:** Slope erosion – northeast corner.

Employing surface reinforcement systems from the FDOT approved geosynthetic products in the area of the exposed slope along with vegetation maintenance will reduce the chances of future slope failures and erosion. Using geosynthetic reinforcement should also reduce future maintenance cost compared to Option 1. It should be noted that if this option is selected, the installation of the geosynthetic material requires clearing all the existing vegetation, re-grading the slope and re-planting over the geosynthetic erosion protection material.

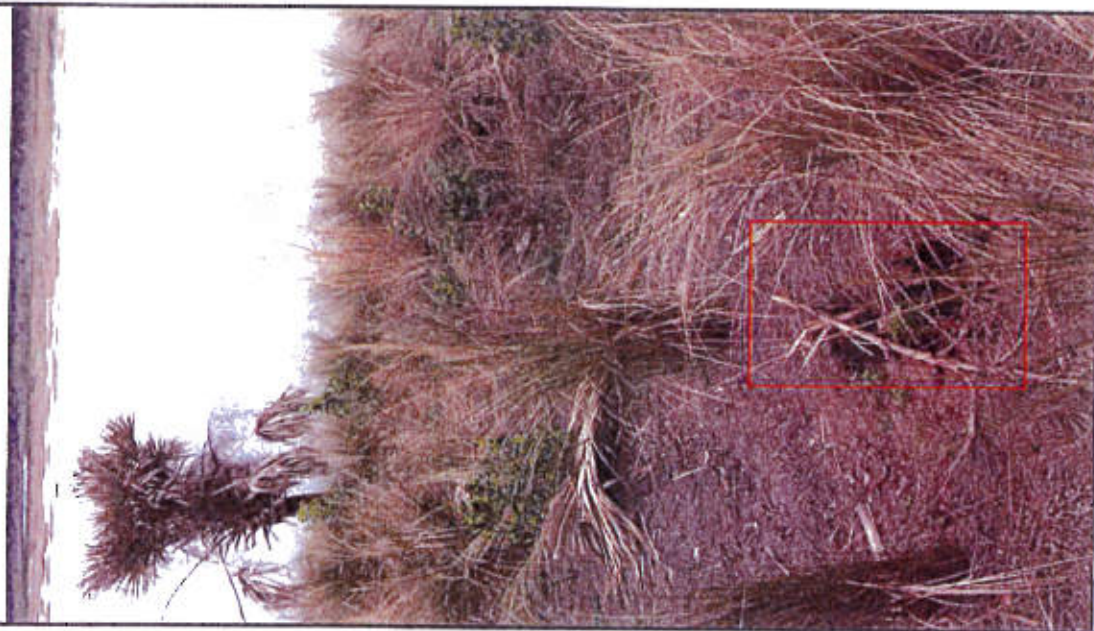
**Photo 10:** Slope erosion – northeast corner.

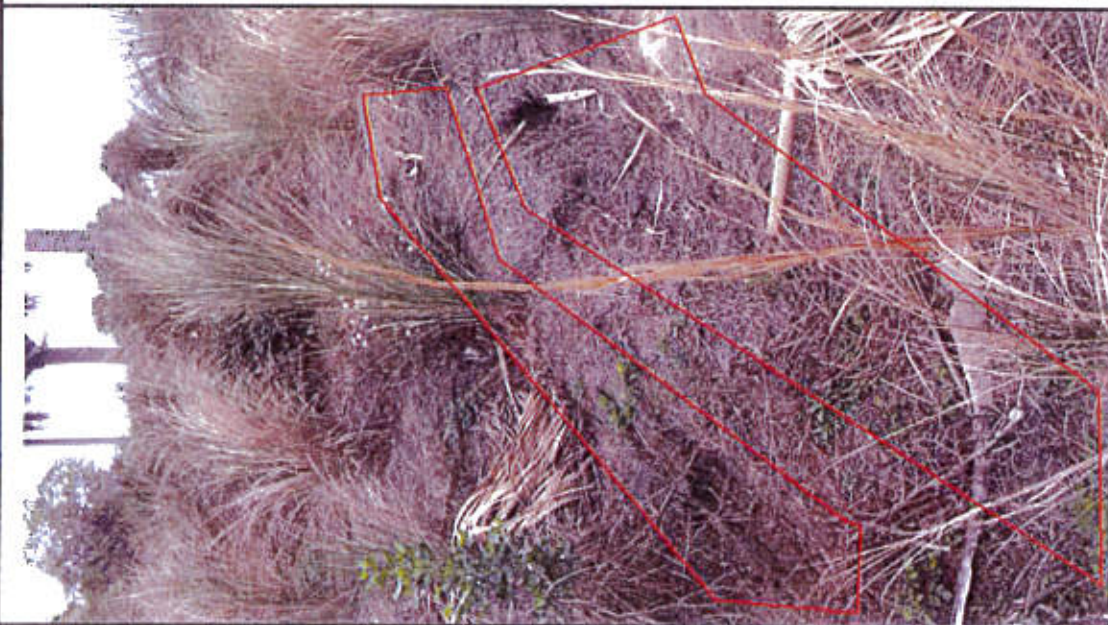
**Photo 12:** Slope erosion – northeast corner.

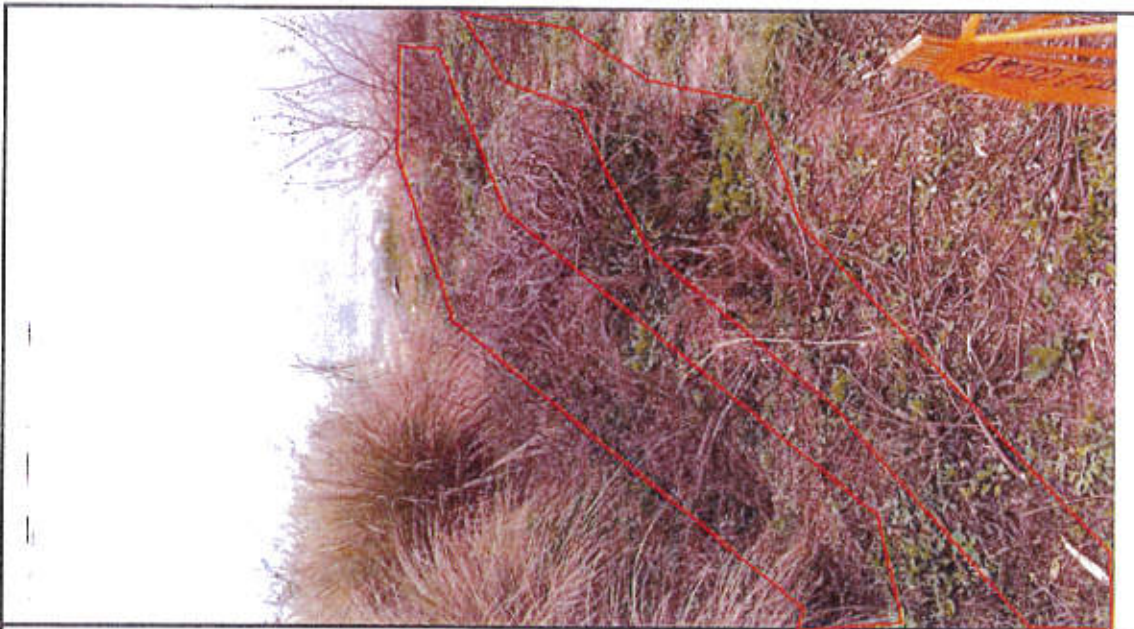
**Photo 13:** Slope erosion – northeast corner

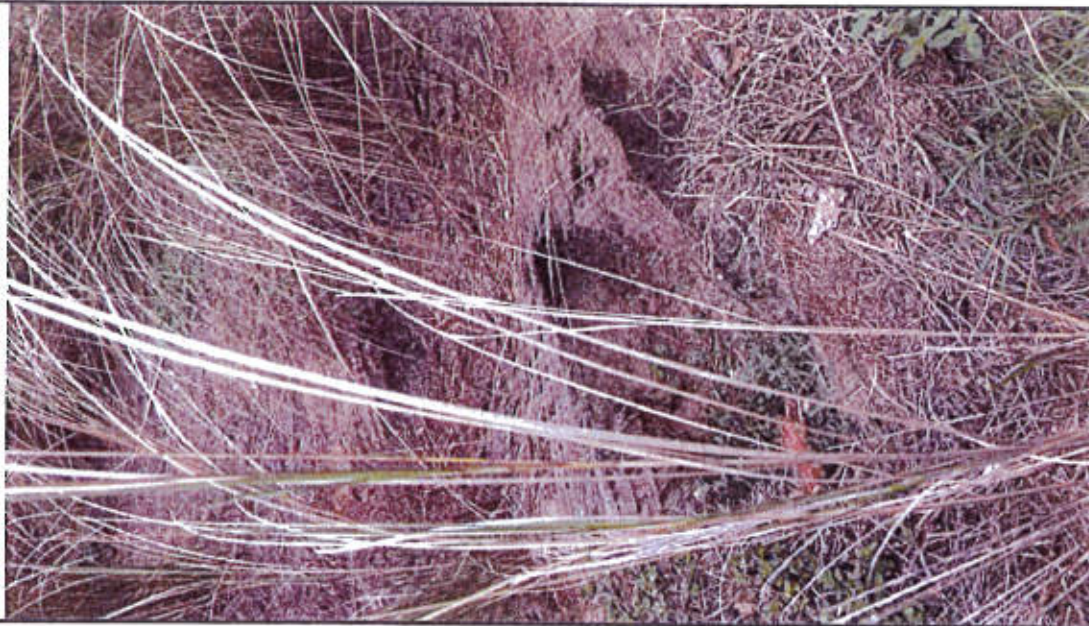
**Photo 14:** Slope erosion – northeast corner.

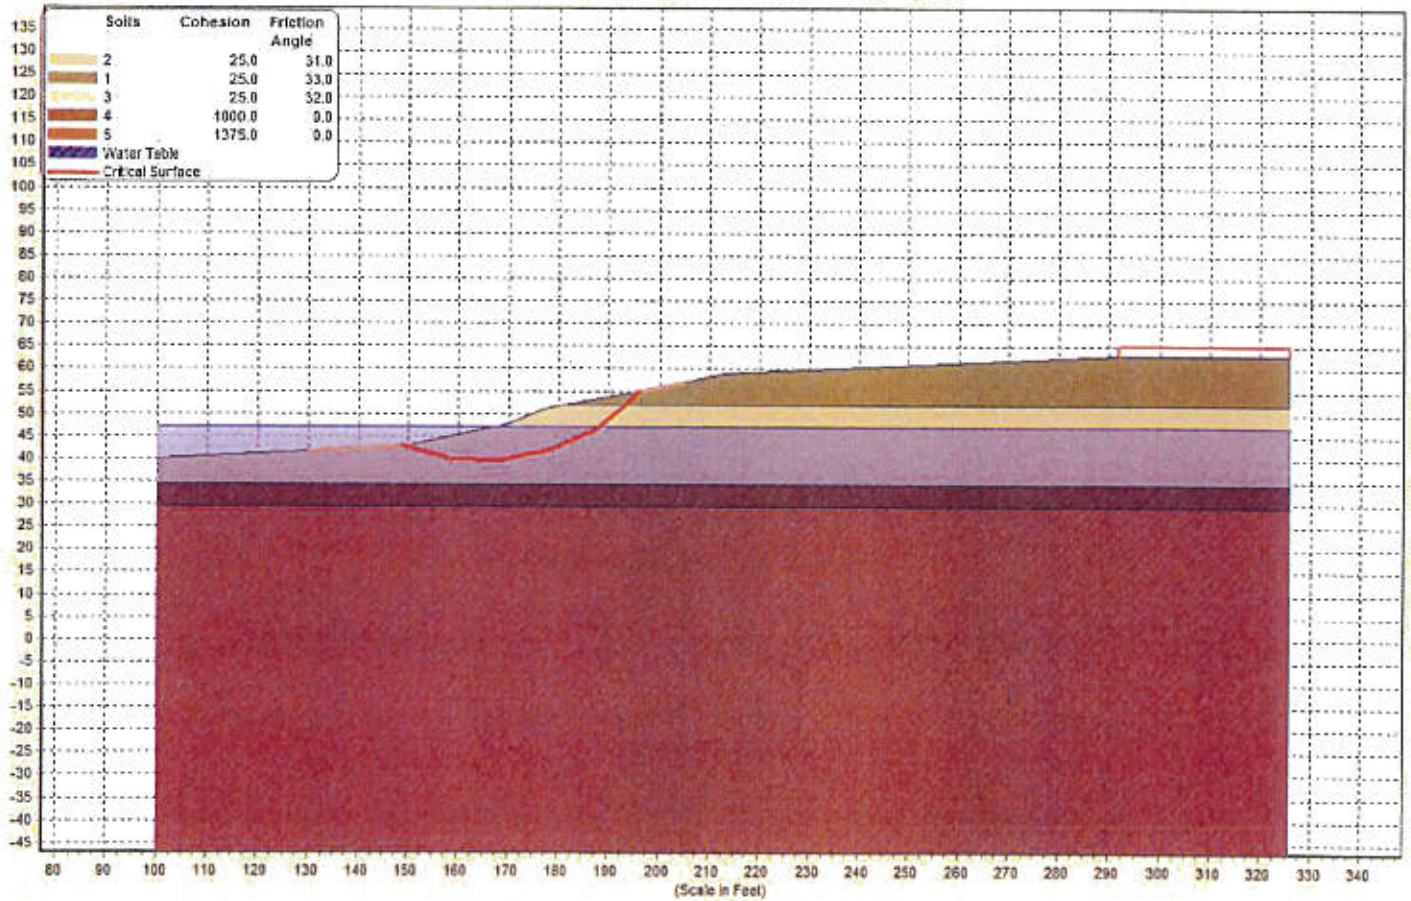
Problem: Morse Island \_B-2 - FS Min- Bishop = 2.163

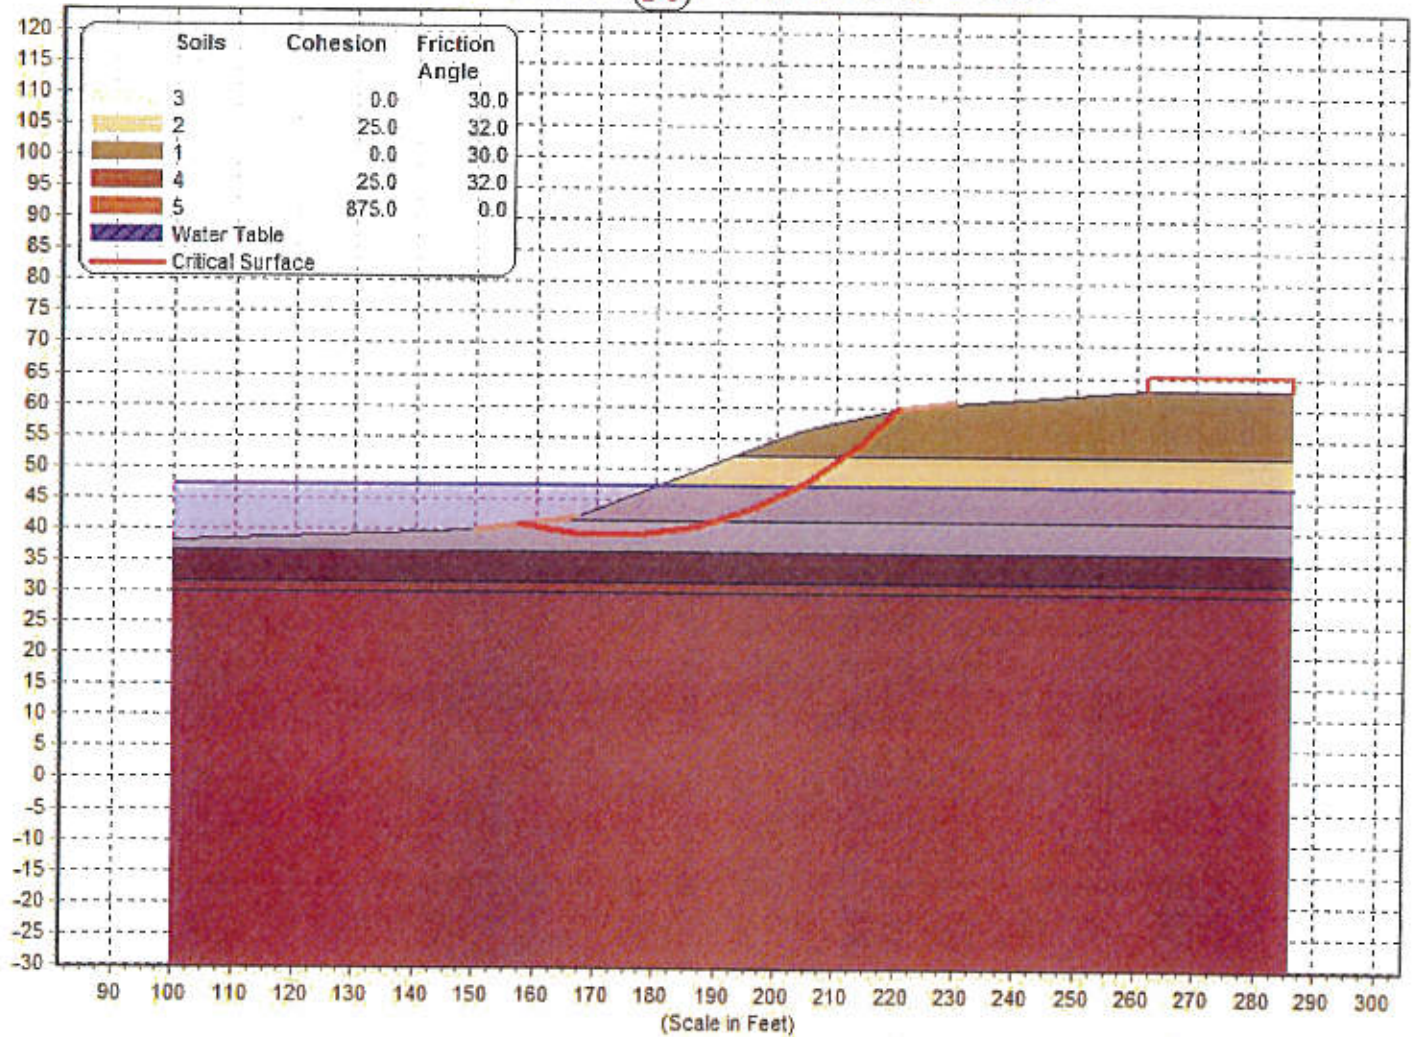
Problem: Morse Isl (B-6) - FS Min- Bishop = 1.681
