# MORSE BOULEVARD LAKE SUMTER SLOPE STABILITY ANALYSIS

## Sumter Landing Community Development District

**Kimley-Horn and Associates, Inc.**

July 2016

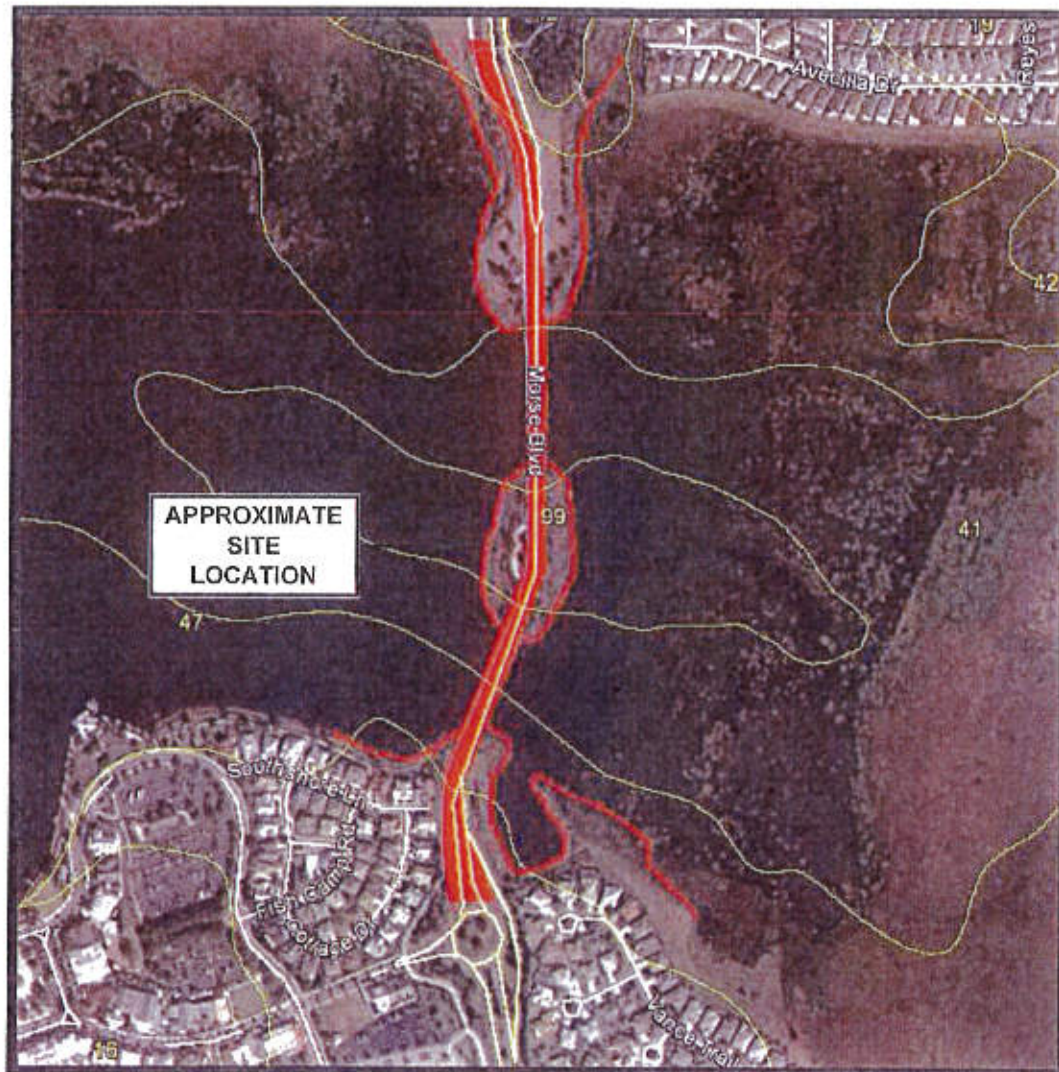
| CHECKED: EWN | DATE: 5-24-16 | FIGURE: 1 |

An excerpt of the NRCS Sumter County Soil Survey Map is shown on **Figure 2** of the **Appendix**. Note, that when reviewing the soils map, the maps were generated before Morse Boulevard and the causeway were constructed. The included **Figure 1** shows the island in Soil Series 41 and 99. Soil Unit 99 is water. The soil survey maps have not been updated since the construction of Morse Island.
